CASE STUDY

3D CRANE BOOM SURVEY AND STRUCTURAL INTEGRITY ANALYSIS

Jack-up drilling rig

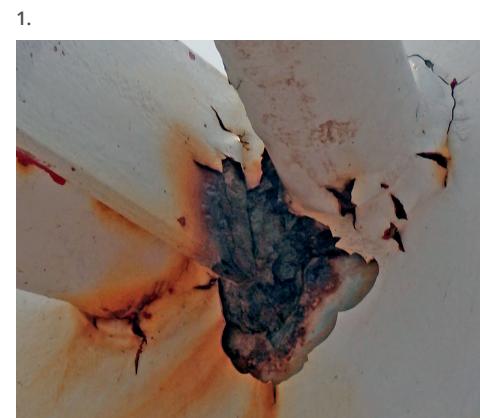
Following a Non-Destructive Testing (NDT) inspection of the three pedestal cranes on board the jack up rig, it was found that all three booms had surface corrosion covering over 50% of their total surface area. A criterion set by the crane manufacturer states that if surface corrosion exceeds 50% of the boom's total surface area, replacement is required; as a result, all three booms were condemned by the manufacturer, with a replacement cost totalling \$2.25 million. This criterion does not account for wall thickness loss due to corrosion.

1.
Corrosion found on one of the crane booms.
