SPARROWS

CASE STUDY

CRANE BOOM CHANGEOUT ON SINGLE CRANE ASSET

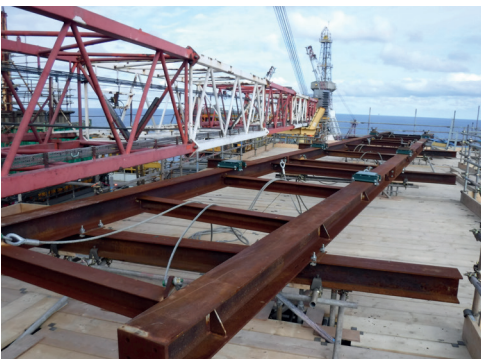
1.

Installation of skid frame for accepting new boom.

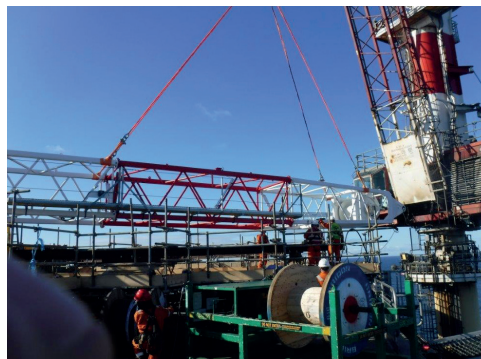
2.

Lifting on new boom first two sections.

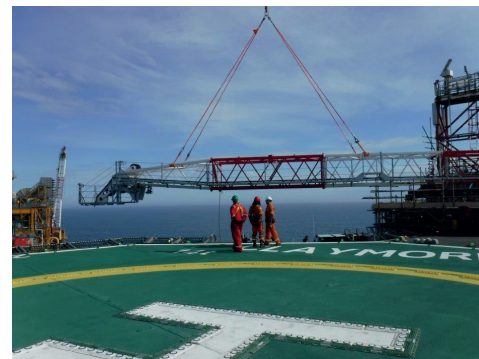
3.

Connection of final sections of new boom.
