# CRANE REMOVAL, REFURBISHMENT AND RE- INSTALLATION

Crane removal for full refurbishment removing structural, mechanical, electrical, hydraulic anomalies to extend operational life

Spirit Energy

DP6 / 8 platform

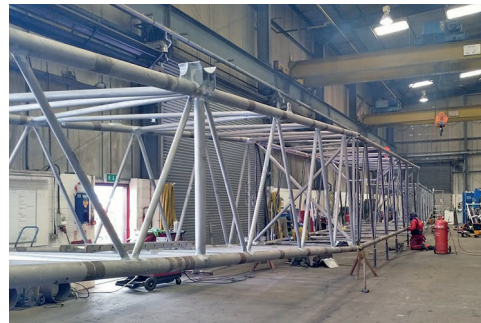
1.

Full boom refurbishment.

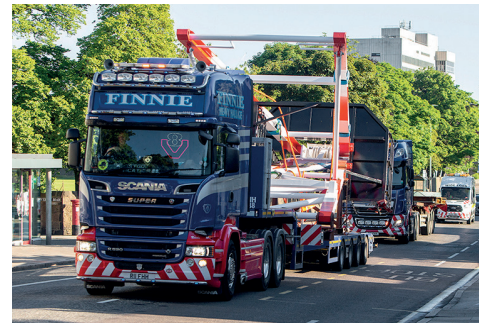
2.

DP8 crane being transported from Sparrows workshop to Aberdeen harbour.

- Onshore completion of the refurbishment meant an implementation team wasn't required on-board
- During removal of the DP6 crane it was identified that the deconstruct of the crane for road transport to Aberdeen could be streamlined for the re-build and re-installation if the crane was fully built and commissioned, minus boom and A-frame, onshore at Sparrows yard and shipped back to the platform on a supply vessel
- Transporting the crane from Sparrows workshop to Aberdeen harbour required wide load notifications to be lodged with Police Scotland and the local authorities. The 10-week notification period was a critical aspect of the workscope and planning and execution had to be tightly monitored
- Sea fastening was designed and installed to ensure the safe and secure shipment of the crane to and from the platform
