Crane and surrounding area fabric maintenance and repairs

LOCATION North Sea

Fabric maintenance and remedial works to deal with defects and corrosion

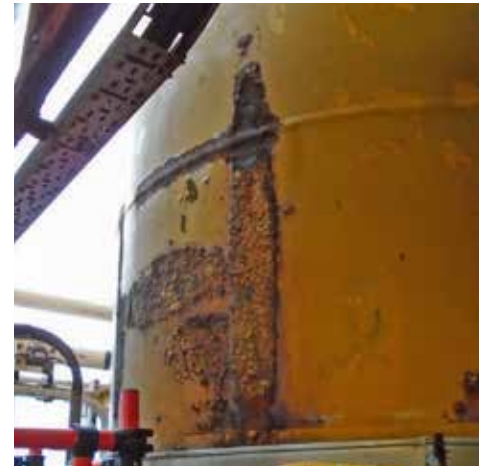
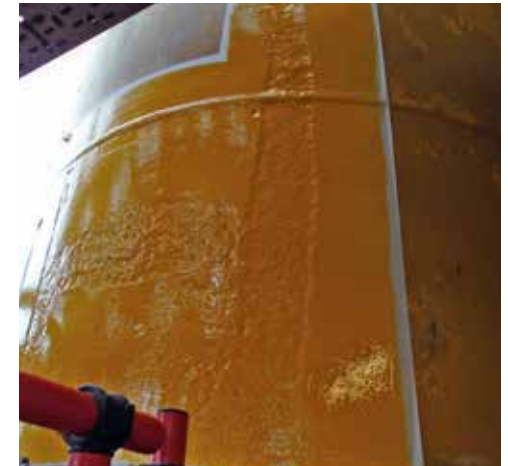
Crane pedestal before and after

- Sparrows were approached to undertake fabric maintenance (bristle blast / sand, prime and paint) on various crane areas for a UK client, including the boom, A-frame, A-frame handrails, boom backstops, nav light stanchions, main frame and machinery house

- Due to the high saline environment offshore, corrosion is prevalent in crane structures and components. Fabric maintenance can minimise and slow down further degradation before major structural components require further, more intensive remedial works. As the current crane incumbent, Sparrows were the logical choice to undertake these works, as it complements our current crane mechanical maintenance and uptime, aesthetic and structural wellbeing responsibilities
