Motor operated valve change out

Pipeline
UK

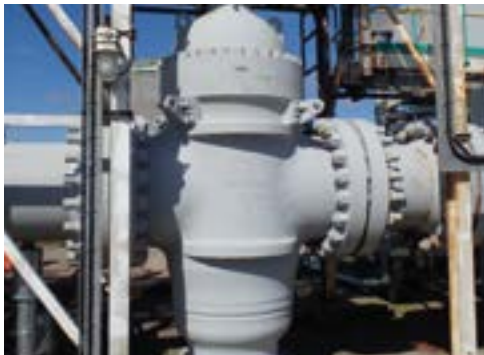
1.

Motor operated valve prior to removal

- With the valve being changed out located in close proximity to a live 36-in sealine pipe, the lift had to be planned and executed with great precision.

- A top and tail procedure was required to lay the valve flat to enable it to be transported safely. The existing lifting padeyes attached to the valve were not designed for this type of lift. We designed, fabricated and tested a bespoke arrangement using Finite Element Analysis (FEA) to design a plate to interface with the valve and accommodate an off the shelf swivel hoist ring.

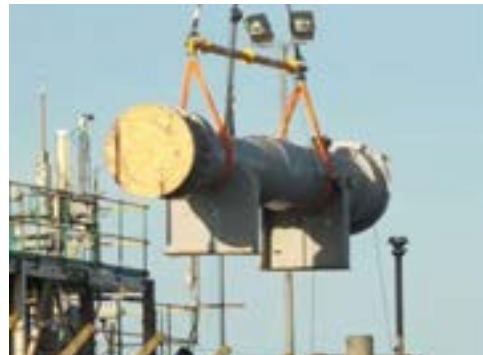
2.

Pig receiver mid lift

- Lift plans were created to remove the walkways and receiver to free up room around the valve, while great care was taken to ensure the face of the flanges between the receiver and valve were not damaged.

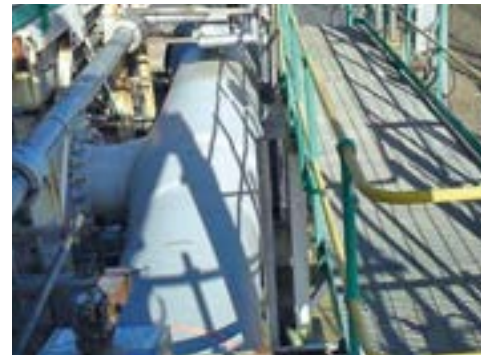
3.

Pig receiver prior to walkway destruct
