Phased Array Ultrasonics (PAUT) inspection of crane motor armature shafts

Jack-up drilling rigs
UK and Norway

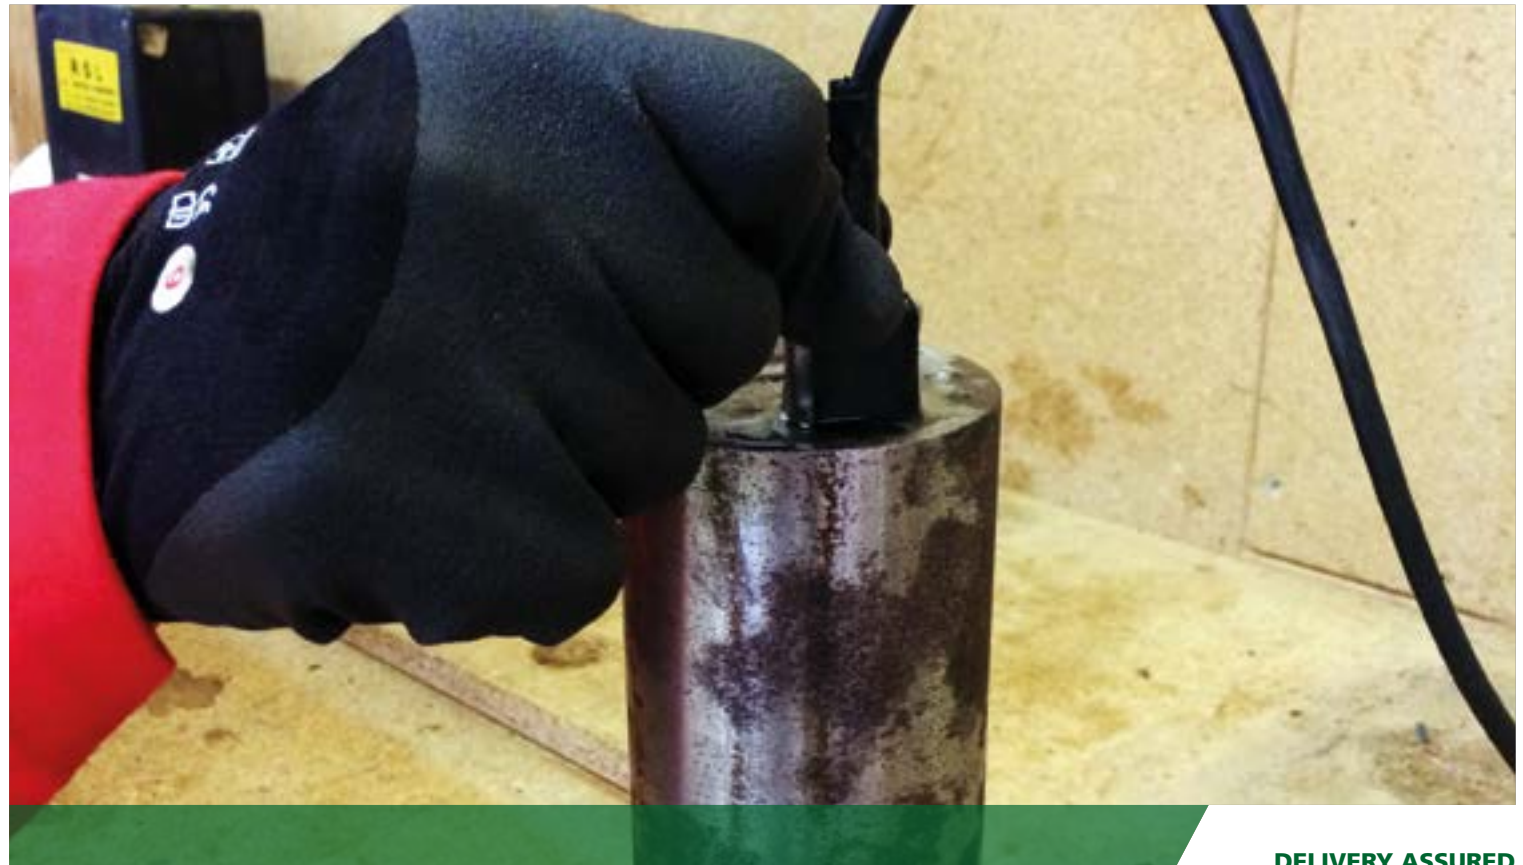
Our inspection team were asked by the customer to provide a fully comprehensive inspection of N9/N11 crane motor armature shafts.

In addition to this, using conventional NDT methods limits access during inspection due to the geometry / orientation of the component, meaning the internal areas of the crane armature shafts cannot be fully inspected.
