Hydraulic retrofit for aft starboard capstan on diving support / well intervention vessel

LOCATION Aberdeen harbour, UK

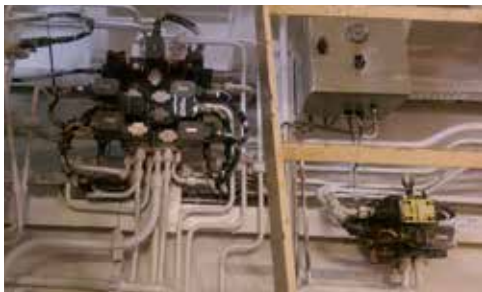
1. Control and brake release manifold pre-retrofit.
2. Brake manifold post-retrofit.
3. Control manifold post-retrofit.

- Replace cartridge valves in the hot oil strip manifold
 - Due to differences between the A4V250 and A4VG250 pump, retrofit new external boost filter
 - Remove the hydraulic control / brake release manifolds and send to our Aberdeen workshops for strip down, inspection, clean-up, replacement of valves / blank-off redundant and testing
